Manhole Inspection Summary

Manhole # S17UU_001MH

Insp Date: **8/1/07 12:57 PM**

Location Address: **2301 WICHITA AVE**

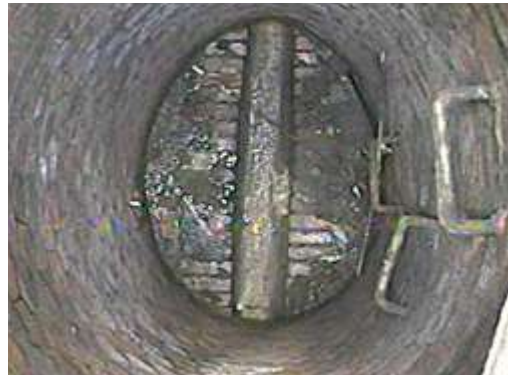
Top View

DEBRIS ON BENCH.

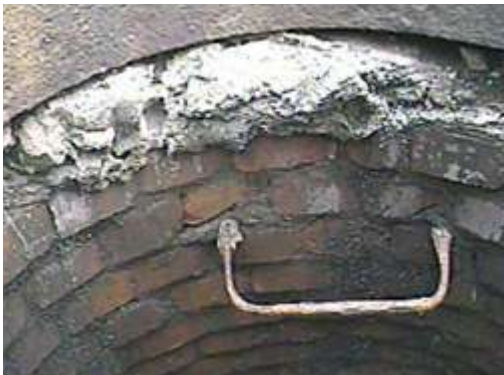
Defect 1

Condition: ☐ Sound ☒ **Cracked** ☐ Root Intrusion ☐ Loose Brick ☒ **Deteriorated**

Steps Count: **5** Missing: **0** ☒ **Corroded**

PIC OF FRAME CRACK AND
DETERIORATED AND SEVERLY
CORRODED STEP.

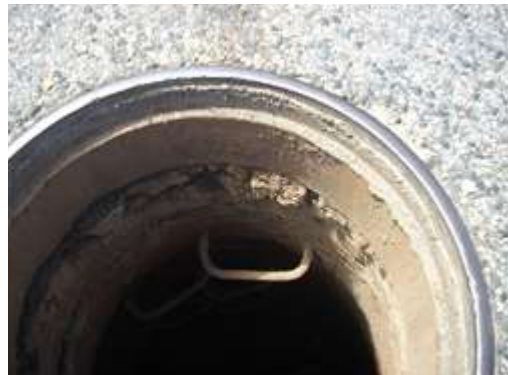
Defect 2

FRAME OFFSET

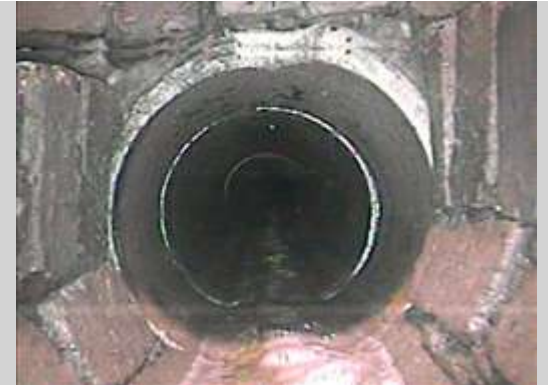
12 O'Clock Outflow

8 in. Circular Gravity Sewer
Pipe Out @ 12 O'Clock

Pipe Height: (in.) Direct
Pipe Material: **Clay** ☐ Pipe Lined
Invert Depth: **9.65** (ft.) Flow Characteristics: **Fast**
Deposits: ☒ None ☐ Mud ☐ Sludge ☐ Debris ☐ Grease
Silt Depth: (in.) Deposits Extent:
Infiltration: **None** Pipe Seal Cond: **Sound**

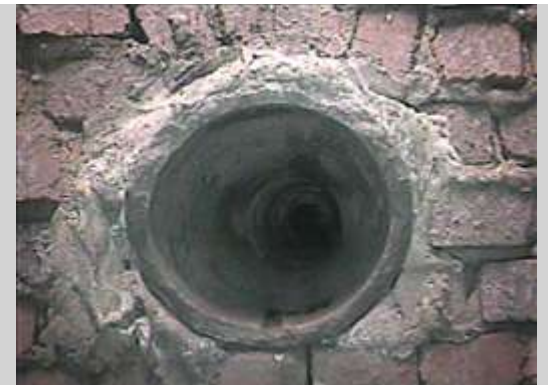
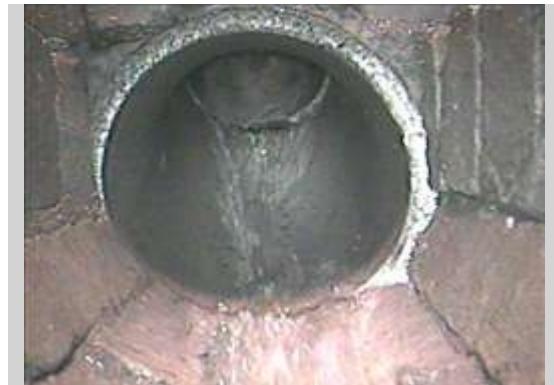
6 O'Clock Inflow

8 in. Circular Gravity Sewer
Pipe In @ 6 O'Clock

Drop In @ 6 O'Clock

Pipe Height: (in.) Direct
Pipe Material: **Clay** ☐ Pipe Lined
Invert Depth: **5.60** (ft.) Flow Characteristics: **Fast**
Deposits: ☒ None ☐ Mud ☐ Sludge ☐ Debris ☐ Grease
Silt Depth: (in.) Deposits Extent:
Infiltration: **None** Pipe Seal Cond: **Sound**

Drop: **Outside Direct**
Angled: Reading: (ft.)
Inv Depth: **9.60** (ft.)
Drop Condition: **Open**

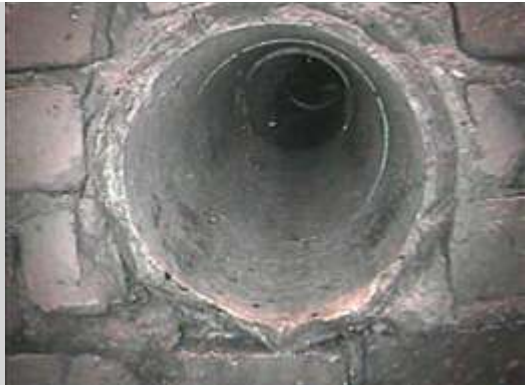
8 O'Clock Inflow

8 in. Circular Gravity Sewer

Pipe In @ 8 O'Clock

Connects To: **House connection / Service line**
